## **SAFETY ALERT FROM THE FACTORY**

### **VIKING – CRACKS IN THE HORIZONTAL STABILIZER ATTACHMENT TUBE**

Rev B 20 January 2004

**MODELS: 14-19-3A, 17-30, 17-31, 17-31TC, 17-30A, 17-31A & 17-31ATC All Serial Numbers.**

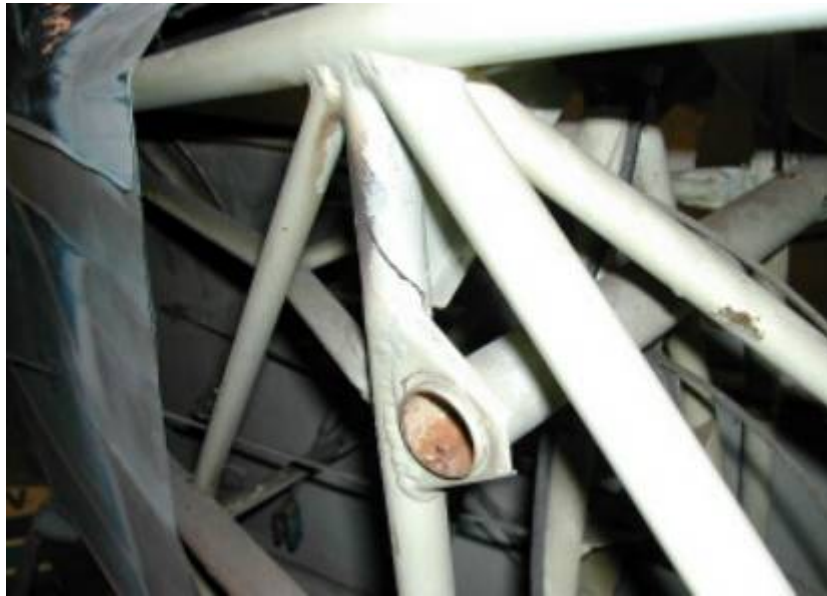
Photo # 1: Right Side Looking Inboard/Aft

Alexandria Aircraft LLC has received a field report of severe cracks in the vertical tube that supports the horizontal stabilizer on a 1967 Viking Model 17-30. The airplane had approximately 3700 hours TT. The cracks are shown in the following three photographs; fuselage fabric was removed after the cracks were discovered to facilitate repairs. The cracks are on both left and right tubes and appear to start near the point where the horizontal stabilizer carry-thru tube support bracket flange is welded to the vertical fuselage tube. There are also cracks in the

carry-thru tube support bracket. They are on both sides at the edge of the weld. Looking inboard at the right bracket, they are at the 11 o'clock position (see Photo # 1). Looking inboard at the left bracket, they are at the 4 to 5 o'clock position (not visible on the photographs).

Alexandria Aircraft LLC recommends that owners/operators of all Model 14-19-3A, 17-30, 17-31, 17-31TC, 17-30A, 17-31A and 17-31ATC All Serial Numbers have their aircraft inspected for this condition. The inspection should look for cracks 1) in the vertical tubes at Fuselage Station # 7 which support the horizontal stabilizer paying special attention to the area where the horizontal stabilizer carry-thru tube support bracket flange is welded to the vertical fuselage tube, and 2) in the carry-thru tube support bracket at the edge of the weld around the aft side of the carry-thru tube (inboard and outboard sides). If the Service Kit is not installed, the inspection should also look at the upper portion of the vertical tube as required by Service Letter 85A and AD 75-20-06. **The inspection should be accomplished with a mirror and flashlight; it does not require removal of fabric.** This is a potentially dangerous condition and we are trying to get this information out to aircraft owners and maintenance facilities ASAP. We have notified the FAA as we are required to per FAR 21.3: Reporting of Failures, Malfunctions and Defects. We are working with the FAA to resolve this issue. We probably will issue a new service letter and/or revise Service Letter 85A, and the FAA probably will issue a new AD and/or revise AD 75-20-06. The new service letter and AD probably will require a repetitive inspection. **DO NOT WAIT FOR THE UPDATED SERVICE LETTER OR AIRWORTHINESS DIRECTIVE;** have your airplane inspected ASAP. Please report your findings to Alexandria Aircraft LLC: 1) Owner Contact Information, 2) Airplane Model and Serial Number, 3) Total Time, 4) were cracks found as a result of the SL85A/AD75-20-06 inspections, 5) did you find cracks as a result of the inspection described herein and if so, describe where you found the cracks.
